DAF
CF 85 / XF / XF 105
ALL MODELS 360 - 510 HP
10 / 2005-

PROBLEM PREMATURE OIL COOLER FAILURE, INTERNAL BURST > LEAKAGES

Oil Cooler, Nissens #90726

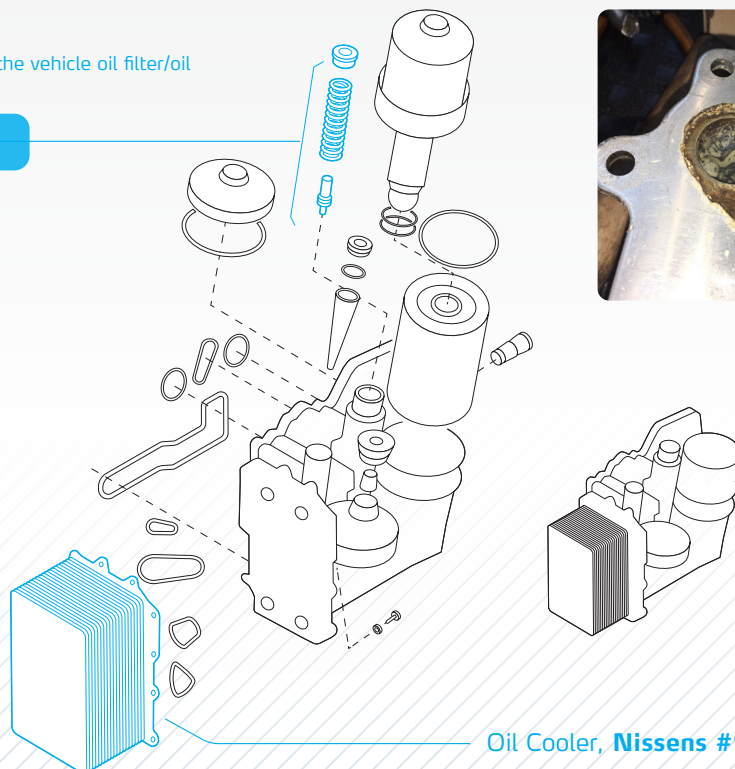
OIL PRESSURE RELIEF VALVE FAILURE > LEADS TO EXCESSIVE LUBRICANT PRESSURE AND OIL COOLER DAMAGE

Pressure Relief Valve location in the vehicle oil filter/oil cooler assembly. OE 1725348

Lubricant mixed with coolant, seen on the oil cooler outlets. One of the most common outcomes of lubricant overpressure and internal bursting of the oil cooler.

- Replace oil and oil filter regularly and according to the vehicle's maintenance schedule.
- Ensure that the lubrication system is clean.
- With an oil cooler failure or/and replacement, make sure to measure the pressure of the lubricant in the system
- **Control the condition of the pressure relief valve, clean and replace it whenever a failure is suspected. The previous oil cooler damage may have its root cause in the valve failure.**
