INA SERVICE INFO Timing belt KITs: 530065010-530065030

Make:	VAG
Models:	refer to catalogue
Engine:	1.6TDi / 2.0 TDi
Year:	2012 onwards
Part Nr:	refer to catalogue

Potential for catastrophic engine failure!

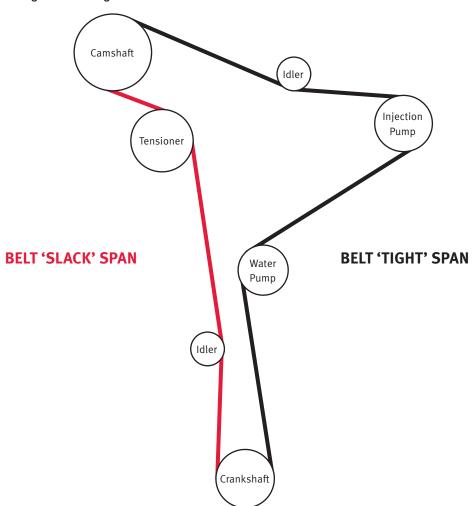
Timing Belt route diagram

If the Camshaft and Injection Pump Sprockets are not released prior to the belt tensioner being set, then only the left hand belt span will be tensioned (shown in red - from the Crankshaft Sprocket up to the Camshaft Sprocket). If not rectified, this amplitude (or vibration) will eventually destroy the tensioner, often causing catastophic engine failure.

Consequently, the rest of the belt is now incorrectly tensioned, so when the engine is started an aggressive belt amplitude will have been created.

Lock camshaft sprocket with pin, counterhold camshaft sprocket, slacken centre bolt 90°, and loosen Torx bolt to allow sprocket to move back and forth in the slotted hole.

Lock with pin, counterhold sprocket, slacken centre nut 90°, this will allow the pump sprocket to rotate back and forth approx. 3 teeth.

Even though the locking pins will still be in place, the sprockets must rotate to allow uniform belt tension across the complete circumference of the belt.
