MCK0100,* MCK0101, MCK0102, MCK0103, MCK1120

TIPS FOR THE CORRECT FIXING OF THE CRANKSHAFT SCREW ON THE OIL PUMP FLANGE.

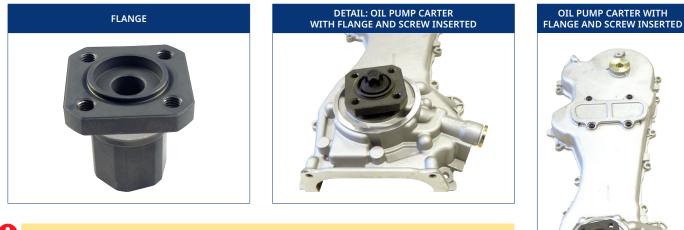
The O-Ring is correctly in place when it is close the screw head.

The screw is inserted into the flange bore and the screw head encounters the top of the flange itself. The O-Ring rests on the flared part of the flange and avoid oil leaking between the two parts.

If the O-Ring is not correctly in place, when inserting the screw into the flange hole or during the tightening, it may tear/break when it encounters the flared part of the flange, compromising the seal.

It is recommended to lubricate the O-Ring (correctly placed) before the screw installation. It is recommended to tighten the screw with following tightening torque values included between 47 e 52 Nm (72°-78°), or following the producer indications.
