febi 107993

Toyota Avensis, Corolla 2.0 D4d

Suction Control Valve

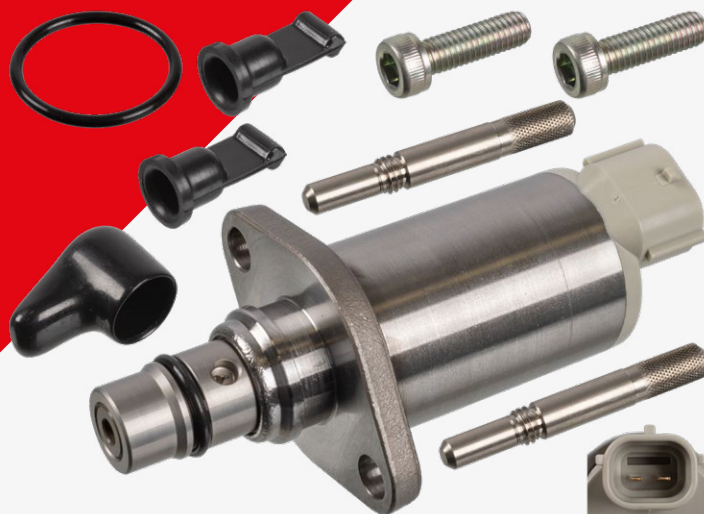
Engine surging, erratic idle and a sudden lack of power which can be intermittent. Engine fault codes logged relating to fuel rail pressure deviation.

The suction control valve (SCV) solenoid has extremely fine tolerances within its moving parts, which are quickly affected by dirt and or contaminated fuel.

A worn or contaminated SCV will cause the high-pressure fuel pump to deliver an inconsistent fuel pressure compared to what is being requested, by the engine control unit (ECU). Inconsistent fuel pressure at the injectors can cause surging as the ECU attempts to find the correct operating fuel pressure.

Check the fuel system for contamination, replace the fuel filter and suction control valve.

Remove the SCV, noting the connector position of the SCV to the pump, loosen bolts and remove. Then remove the large O-ring.

Install the new large O-ring to the fuel pump. Then, screw the two new guide pins into the mounting holes and apply engine oil on the small O-ring located on the SCV before fitting to the pump.

Install the SCV by carefully pushing it into the housing. When the SCV is in position, remove the guide pins, fit the new bolts, and tighten them according to the manufacturer's tightening torque.

Once the installation is complete, carry out the supply pump learning procedure and perform a high-pressure pump test using a suitable diagnostic tool to confirm that there are no leaks and that the fuel system is performing correctly.
