Vacuum pump for Mercedes-Benz diesel

Damage due to wear on the cam

Vehicle: Mercedes-Benz	Product: Vacuum pump
Model series	PIERBURG no.
Various models from model year 1968 with diesel engine	7.20208.../7.20547.../7.20607...

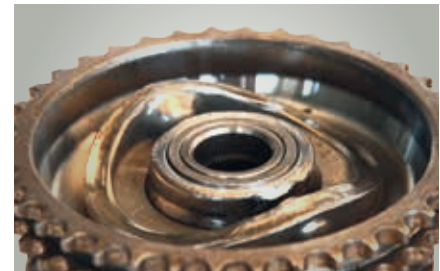
If the cam is worn, the cam roller of the finger type rocker starts to “jump”, gains notches as a result of the impact and causes rattling noises. In the worst case scenario, the feed roller can fall apart and the individual parts can get in to the primary drive.

Worn cam

If the cam is damaged or worn, the injection timer must also be replaced - otherwise the vacuum pump could be damaged.

The sliding surface of a worn cam must never be ground or polished.

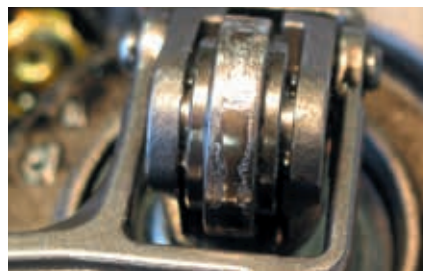
Damage symptoms: Cam roller with pittings due to worn cam.

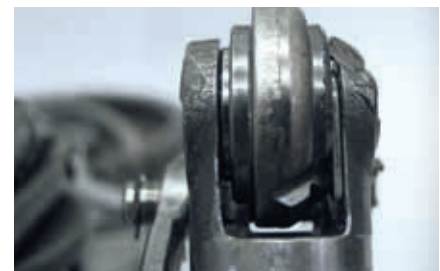
If the sliding surface is polished or ground, it is possible that the impeller will no longer turn with it, meaning that it is worn on one side.

Damage symptoms: cam roller worn on one side

The chips generated by the friction then cause more damage.

The cam should be sent in to enable complaints to be assessed.

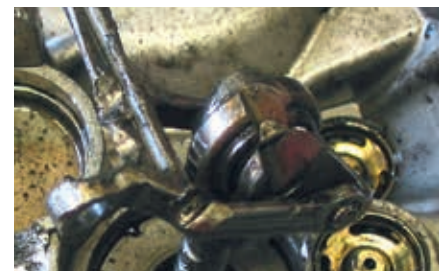
Damage symptoms: completely destroyed finger type rocker
