SI 1066
For technical personnel only!
1/1

SERVICE INFORMATION

RATTLING NOISES

DUE TO OIL SLUDGE IN THE VACUUM PUMP

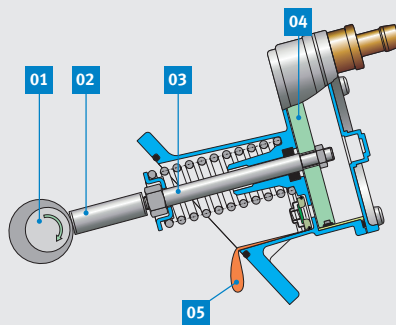
Fig. 1:

The piston vacuum pump is driven by the camshaft (01) through a connecting tappet (02). In the recommended installation position, the engine oil can flow back into the engine (Fig. 1). The installation position in the VW Transporter is as shown in Fig. 2.

Recommended installation position

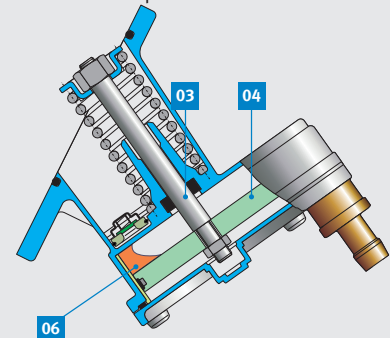
Fig. 2:

Installation position VW LT and T4
