ENGINE TIMING

KD469.14

Assembly/disassembly recommendations

TOYOTA: Avensis, Avensis verso,	ENGINES	OE REFERENCE
Corolla, Corolla verso, Picnic, Previa, RAV4	2.0 D4-D	See below

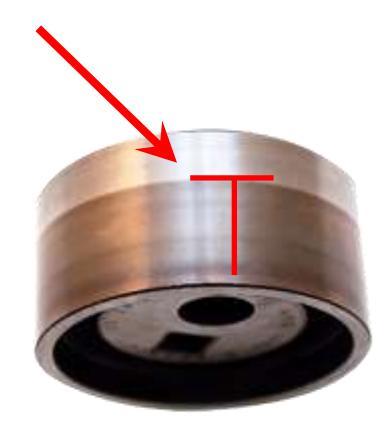
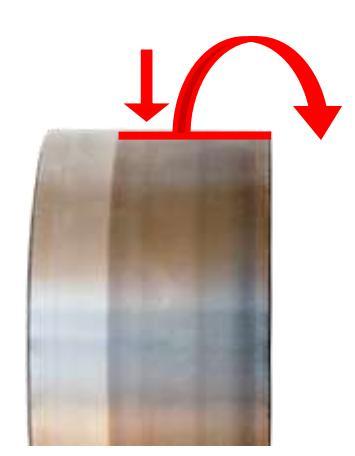
BAD BELT POSITIONING

- Misalignment of timing components or component wear
- Non-standard belt tension
- Roller tensioner GT369.26 not attached correctly

Belt slippage

Improper positioning of the belt may result in a misalignment of the load leading to abnormal bearing running. This anomaly affects other components of the timing system and can lead to in the short-term a seizure of bearings with balls being ejected.
