CVJ – ENG/02 – 05/2019

CV BOOT KITS

Recommended clamp tightening procedures

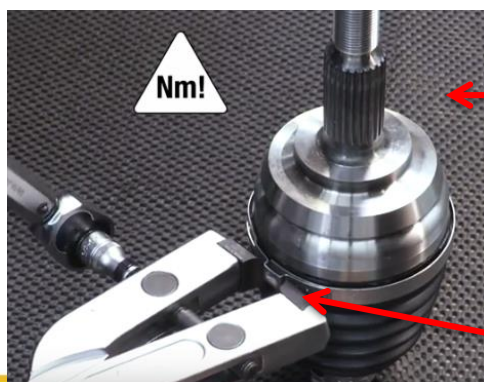
. If the clamp is **not tight enough** :

($M_1, M_2 > \grave{a} 4\text{mm}$)

➤ Grease leakage

. If the clip is **too tight**:

($M_1, M_2 < \grave{a} 1.2\text{mm}$)

➤ The CV boot can split and allow grease to leak

BOOT CLAMP MUST BE
HOOKED SURELY

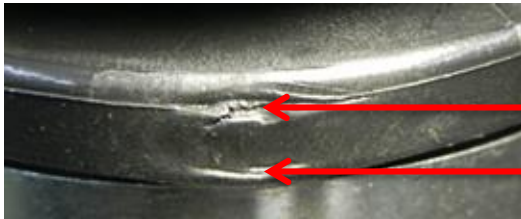
Tightening too strong/tight

The radial compression of the boot is higher to the acceptable limits by the boot. The compression will cause a cutting on the boot.

Cutting area on the boot caused by the deflection running

The manufacturers fitting instructions and specified torque setting should always be followed. The correct tools should always be used for the removal and fitment process.
