VALVE BLOCK - AIR LINE DIAGRAM

11-17 BMW 5 SERIES GT (F07)
09-15 BMW 7 SERIES (F01/02/04) (FIGURE 1)

14-18 BMW X5 (F15)
15-19 BMW X6 (F16) (FIGURE 2)

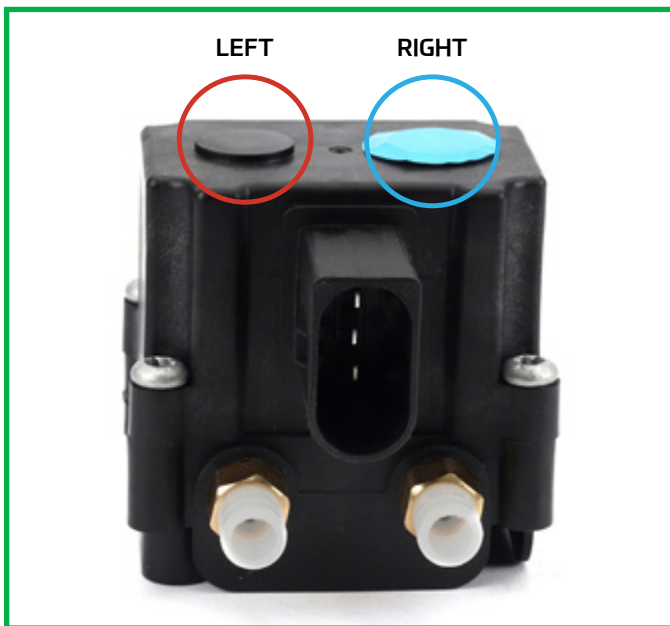
FIGURE 1

NOTE: The colored dots on the valve block **match** the air line colors.

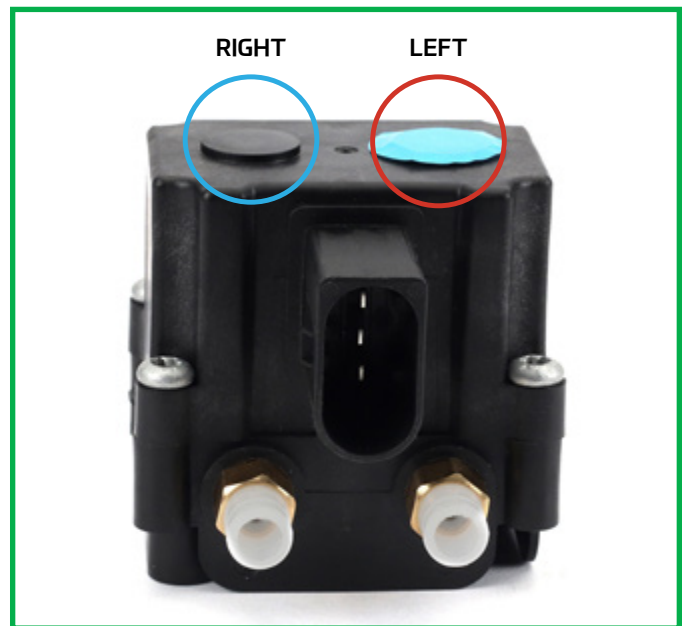
FIGURE 2

NOTE: The colored dots on the valve block are the **opposite** of the air line colors.
