This vehicle contains a "Closed Air Supply System". Replacement of components requires proper adherence to procedures set forth within OE servicing literature. Failure to comply with the OE prescribed procedures can result in component damage and/or failure.

VALVE BLOCK - AIR LINE DIAGRAM

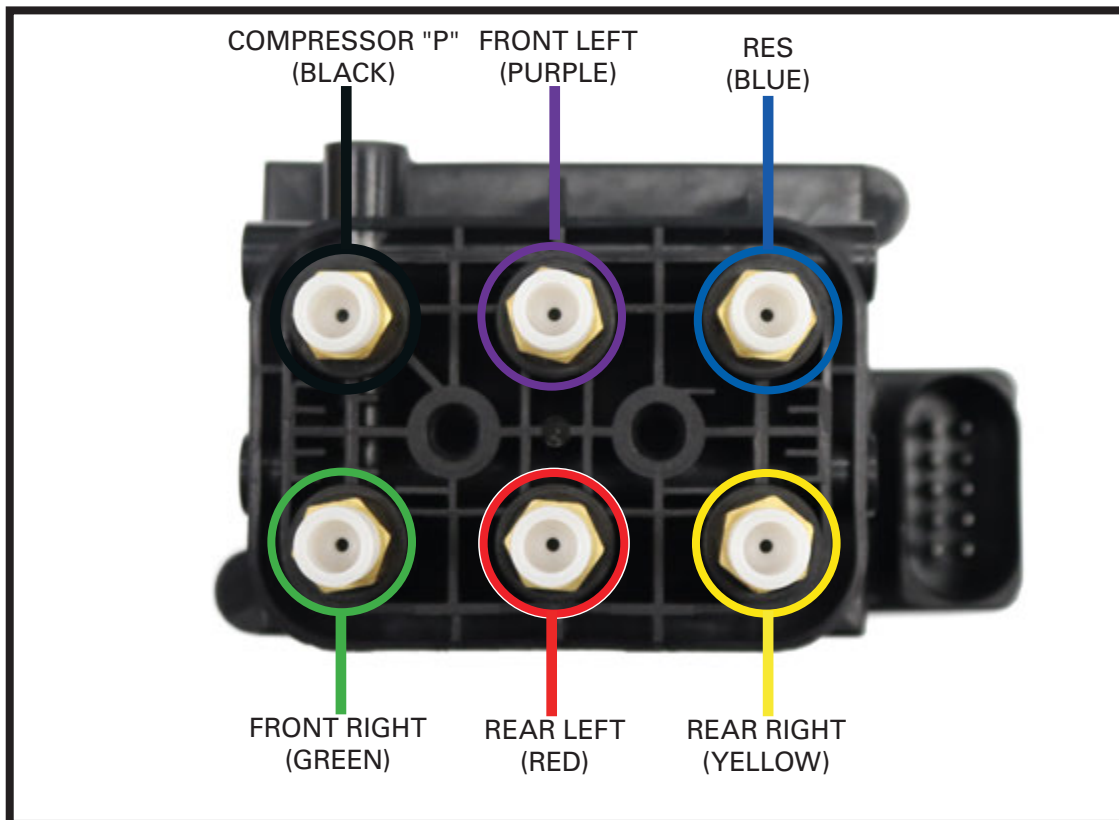
FIGURE 1

1. VEHICLE WILL HAVE MARKED PLATE SHOWING LOCATION OF COLORED AIR HOSE.
