Connecting Cable, camshaft adjuster actuating solenoid

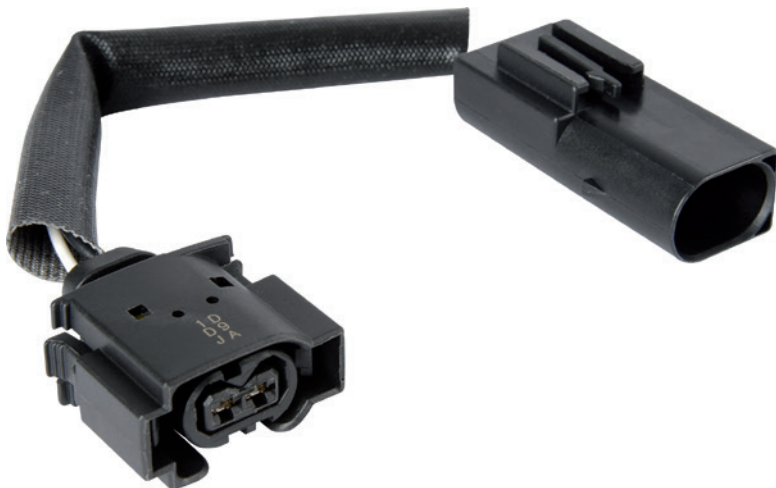
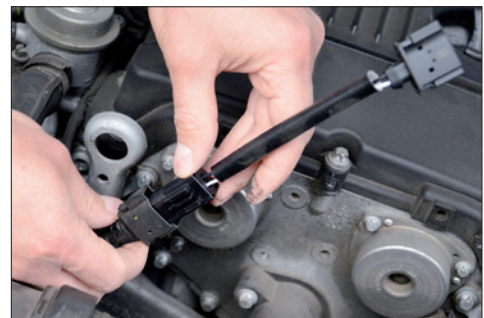
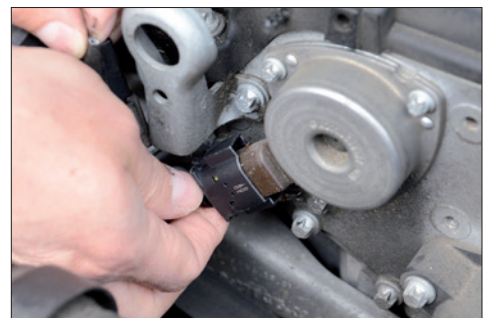
Oil leaking from the camshaft sensor plug is a familiar problem on Mercedes-Benz petrol engines. The fault is design-related and cannot be rectified in the long term by replacing the sensor. Due to the capillary effect, the oil can infiltrate the harness to reach the control unit and eventually cause electronic failure and damage to individual parts. Such damage can be prevented with the Herth+Buss oil-stop cable. Fine copper sleeves have been incorporated into both lines of the oil-stop cable in order to prevent the oil from spreading. These

have subsequently also been wrapped in heat-shrink tubing. We recommend installing one oil-stop cable on every M111 (engine code), two on every M271 and as many as four on every M272 (V6).

How long does it take to fit the oil-stop cable? Fitting it will take a maximum of five minutes. Detach the harness from the sensor before inserting the oil-stop cable from Herth+Buss between the connection on the sensor and the old harness.
