KIA PICANTO CLUTCH CABLE INSTALLATION INFORMATION

Issue Date: 03/04/18 Issue Number: CATB0008B

APPLICATION: Kia Picanto 1.0, 1.1 (2004 > 2007)

APPLICABLE REFERENCES: BKC1495

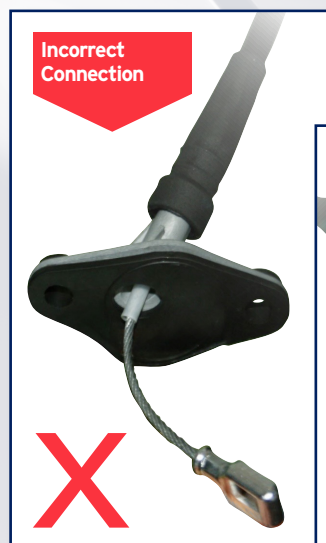
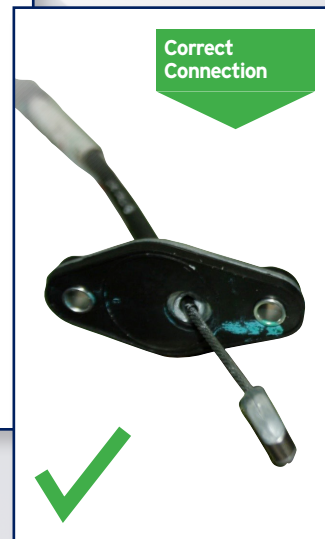
FAILED CABLE DUE TO INCORRECT FITMENT OF BKC1495

If the connection is installed 180° out (upside down) this will result in the inner wire facing the opposite direction and therefore it will have to bend to fit the clutch pedal.

This will result in the inner wire cutting into the conduit culminating in the failure of the inner wire and the subsequent failure of the clutch cable.

When installing the Clutch Cable on a Kia Picanto 2004 > 2007 it is essential that the connection to the bulkhead is installed correctly.

The cable has been manufactured to go through the bulkhead at a set angle so that when fitted to the clutch pedal a smooth in-line operation will be achieved.

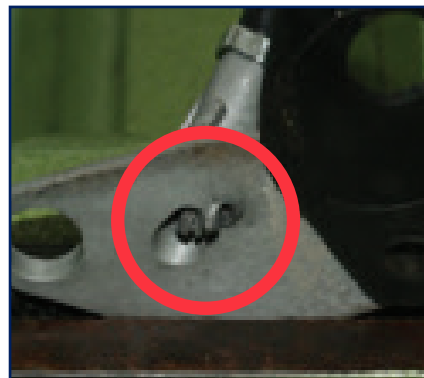
If the flange is fitted in wrong way (rotation of 180°), the wire rope will have to bend to fit on the pedal. This will induce rapid wear and failure of the cable.
