**Certified Automotive Parts Association**

**Vehicle Test Fit Report**

**Report Number:  
VGGF18FL1 /VTF B/20181025**

**New Part Approval (NPA)  
Vehicle Test Fit (VTF) B**

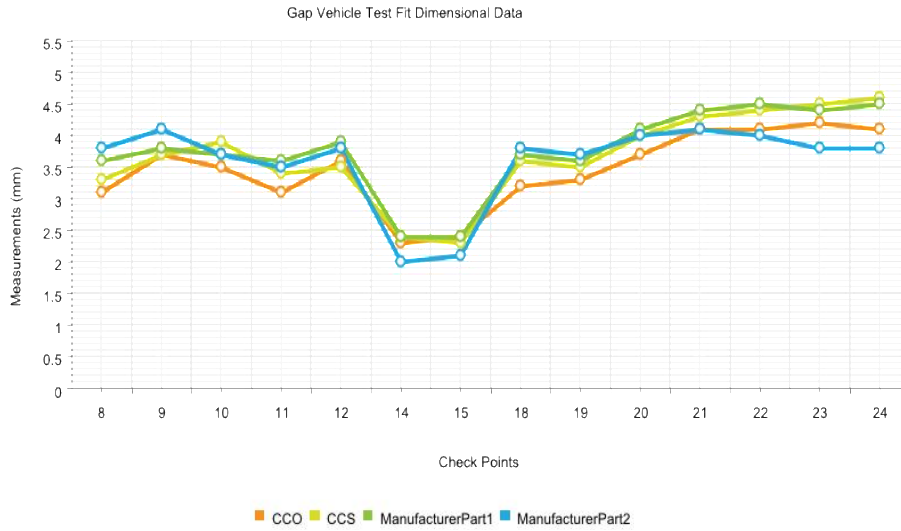
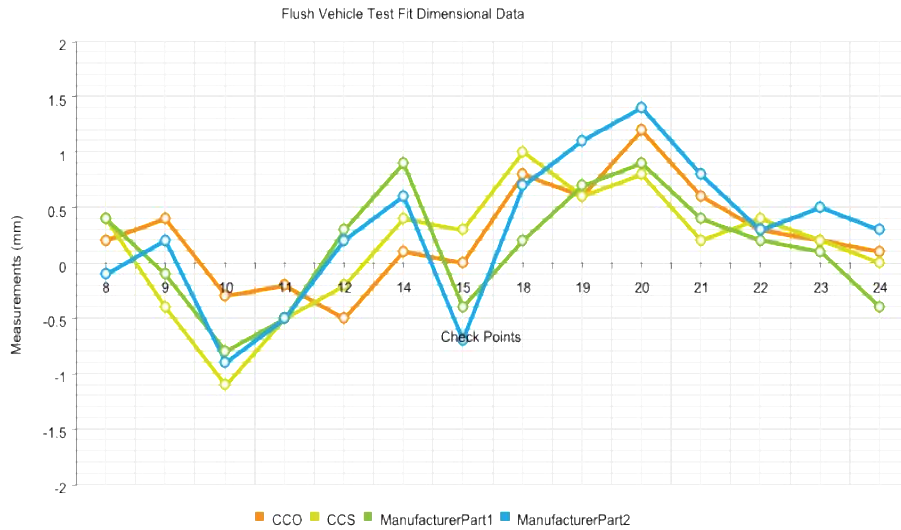
### Vehicle Test Fit Dimensional Data Plot

<b>GAP</b>				
	<b>CCO Part</b>	<b>Mfr. Part 1</b>	<b>Mfr. Part 2</b>	<b>CCS Part</b>
1				
2				
3				
4				
5				
6				
7				
8	<b>3.1</b>	<b>3.6</b>	<b>3.8</b>	<b>3.3</b>
9	<b>3.7</b>	<b>3.8</b>	<b>4.1</b>	<b>3.7</b>
10	<b>3.5</b>	<b>3.7</b>	<b>3.7</b>	<b>3.9</b>
11	<b>3.1</b>	<b>3.6</b>	<b>3.5</b>	<b>3.4</b>
12	<b>3.6</b>	<b>3.9</b>	<b>3.8</b>	<b>3.5</b>
13				
14	<b>2.3</b>	<b>2.4</b>	<b>2.0</b>	<b>2.4</b>
15	<b>2.4</b>	<b>2.4</b>	<b>2.1</b>	<b>2.3</b>
16				
17				
18	<b>3.2</b>	<b>3.7</b>	<b>3.8</b>	<b>3.6</b>
19	<b>3.3</b>	<b>3.6</b>	<b>3.7</b>	<b>3.5</b>
20	<b>3.7</b>	<b>4.1</b>	<b>4.0</b>	<b>4.0</b>
21	<b>4.1</b>	<b>4.4</b>	<b>4.1</b>	<b>4.3</b>
22	<b>4.1</b>	<b>4.5</b>	<b>4.0</b>	<b>4.4</b>
23	<b>4.2</b>	<b>4.4</b>	<b>3.8</b>	<b>4.5</b>
24	<b>4.1</b>	<b>4.5</b>	<b>3.8</b>	<b>4.6</b>

FLUSH				
	CCO Part	Mfr. Part 1	Mfr. Part 2	CCS Part
1				
2				
3				
4				
5				
6				
7				
8	<b>0.2</b>	<b>0.4</b>	<b>-0.1</b>	<b>0.4</b>
9	<b>0.4</b>	<b>-0.1</b>	<b>0.2</b>	<b>-0.4</b>
10	<b>-0.3</b>	<b>-0.8</b>	<b>-0.9</b>	<b>-1.1</b>
11	<b>-0.2</b>	<b>-0.5</b>	<b>-0.5</b>	<b>-0.5</b>
12	<b>-0.5</b>	<b>0.3</b>	<b>0.2</b>	<b>-0.2</b>
13				
14	<b>0.1</b>	<b>0.9</b>	<b>0.6</b>	<b>0.4</b>
15	<b>0.0</b>	<b>-0.4</b>	<b>-0.7</b>	<b>0.3</b>
16				
17				
18	<b>0.8</b>	<b>0.2</b>	<b>0.7</b>	<b>1.0</b>
19	<b>0.6</b>	<b>0.7</b>	<b>1.1</b>	<b>0.6</b>
20	<b>1.2</b>	<b>0.9</b>	<b>1.4</b>	<b>0.8</b>
21	<b>0.6</b>	<b>0.4</b>	<b>0.8</b>	<b>0.2</b>
22	<b>0.3</b>	<b>0.2</b>	<b>0.3</b>	<b>0.4</b>
23	<b>0.2</b>	<b>0.1</b>	<b>0.5</b>	<b>0.2</b>
24	<b>0.1</b>	<b>-0.4</b>	<b>0.3</b>	<b>0.0</b>

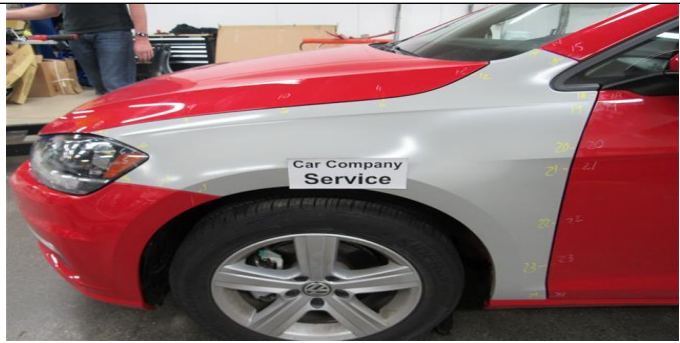
<b>CCS Part</b>	Conforming	Foam rubber present on part: No

Conforming

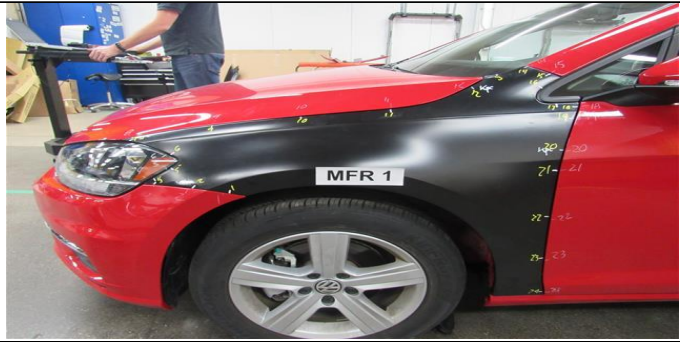
Conforming
