EXHAUST GAS RECIRCULATION

11801

Error Message after Replacement

OPEL AGILA, ASTRA G, ASTRA H, CORSA C, MERIVA, TIGRA

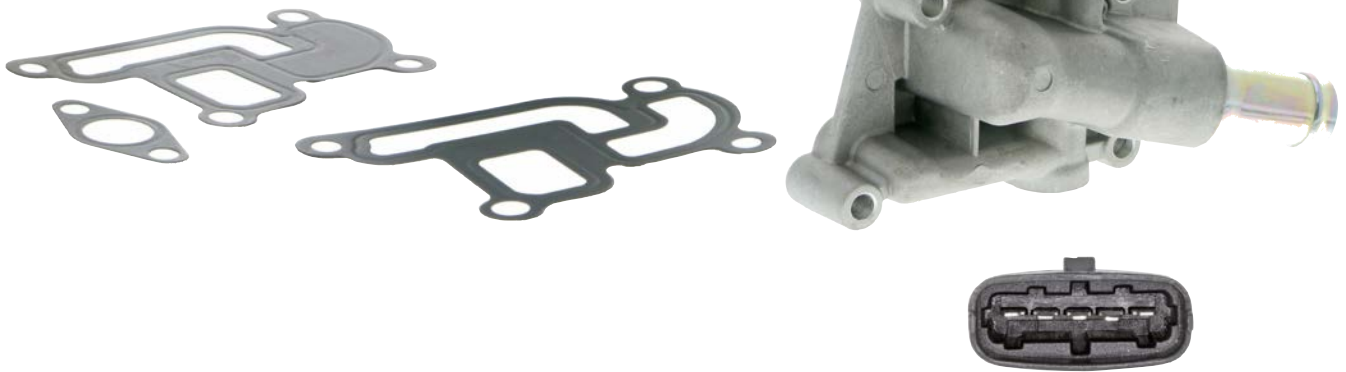
V40-63-0011

- Signal voltage is out of the tolerance range
- New part with an error message
- Error lamp lights up
- Error code P0400

If any of the above problems arise after installing the EGR valve, then the adjustment range stored in the engine control unit is configured wrongly.

With a software update of the engine control unit, the control range can be expanded accordingly, and the problem will thus be solved.
