ENGINE TIMING

KD469.14

Assembly/disassembly recommendations

TOYOTA: Avensis, Avensis verso,	ENGINES	OE REFERENCE
Corolla, Corolla verso, Picnic, Previa, RAV4	2.0 D4-D	See below

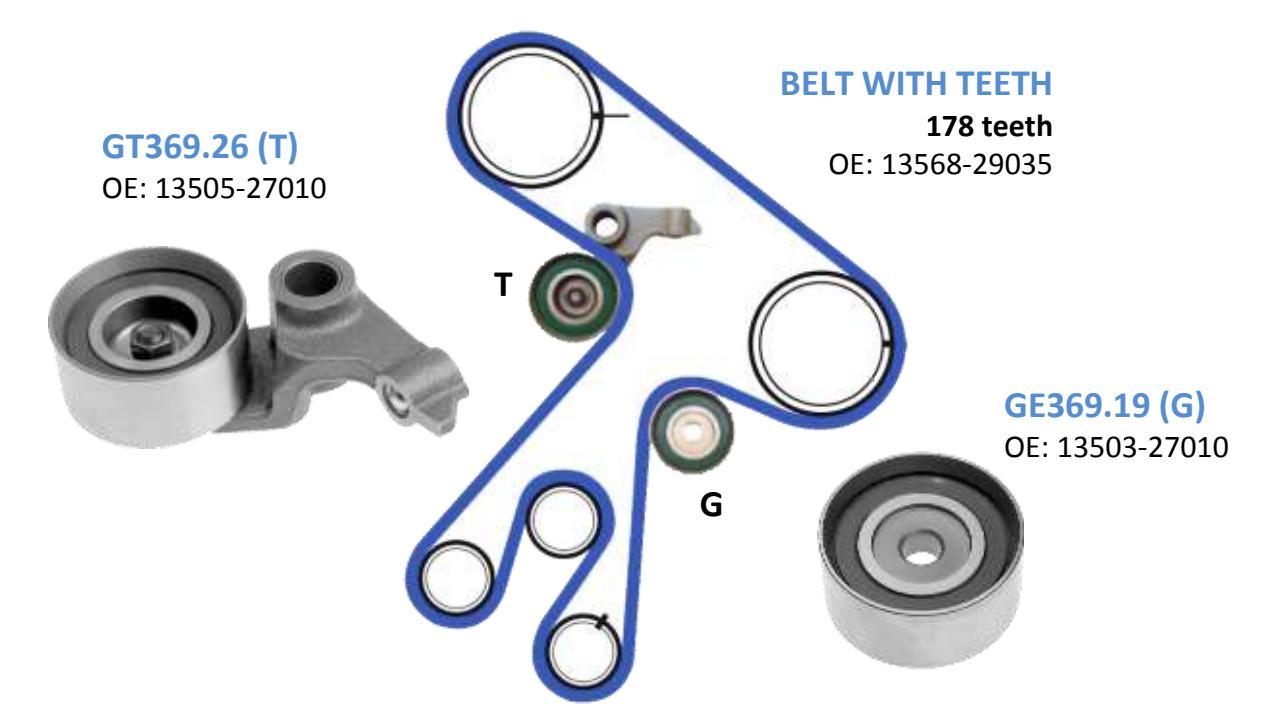
TIMING KINEMATICS OF THE KIT KD469.14

The pulley GE369.19, wound on 2/3 of its surface, is particularly sought after. It is therefore important to check the **correct positioning of the belt** on the roller to avoid any slippage, as a bad load distribution can lead to a malfunction of the roller. The timing belt is characterized by a white Teflon coating which gives good rigidity and high resistance to wear.

NTN-SNR recommends inspection of GT369.40. If this is faulty, look up the complete kit KD469.22.
