DONNEES TECHNIQUES

BULLETIN TECHNIQUE TB-02

BULLETIN TECHNIQUE TB-35

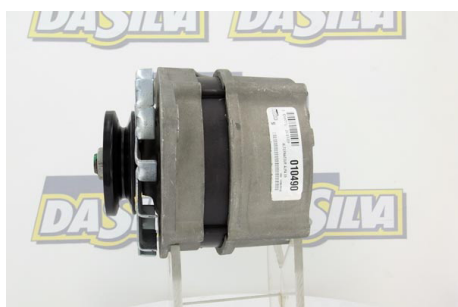
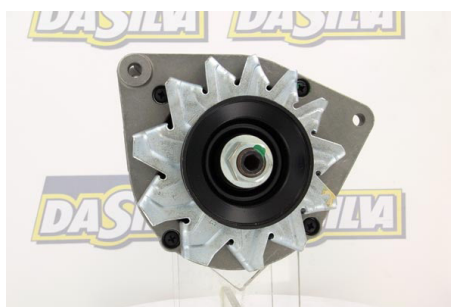
PHOTOS

Courant de charge [A]	65
Type de réseau de bord	pour véhicules 12V
Type de poulie	V
Pince	Plug B+
Connectique	PLUG110
