# 10128700

# MERCEDES

c.c. 4973 (mm) 96.5 (mm)

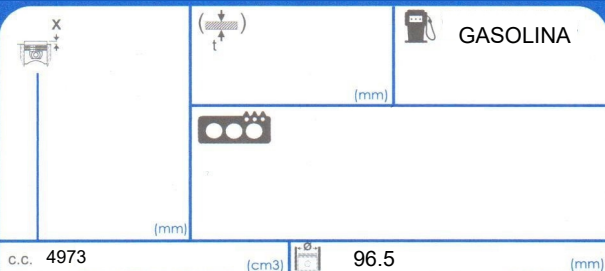
1	MB119.970;MB119.972;MB119.974
2	MB119.970;MB119.972;MB119.974

1	<b>81047700</b>	M12X1.75X160(7),M12X1.75X217(3)
2	<b>81050500</b>	M12X1.75X160(10)
