**Vehicle Test Fit Report**

**Report Number:  
HYSF01F11/COM VTF/20131212**

**Mfr. Part Number: HYSF01F11**

Gordon Auto Body Parts Co., Ltd.  
Hyundai Santa Fe GLS/Limited/LX, 01-06

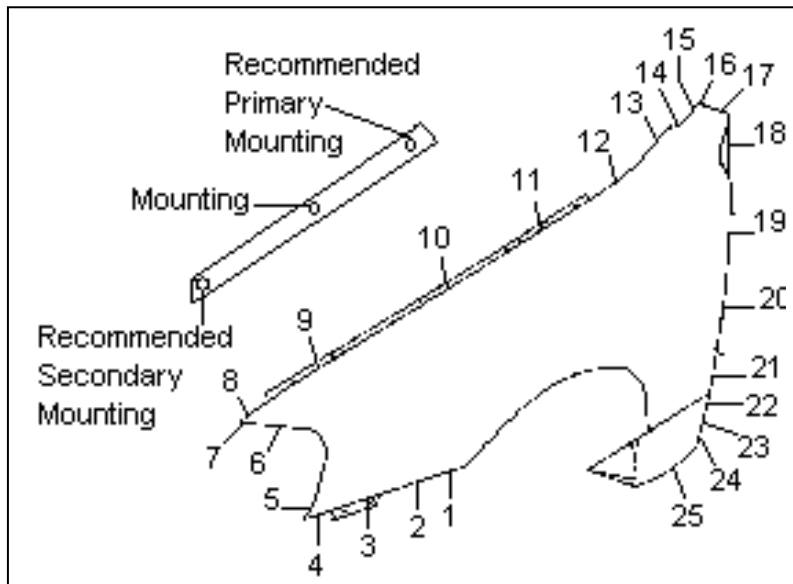
### Part Fit Results

<b>CCS Part</b>	<input checked="" type="checkbox"/> Conforming <input type="checkbox"/> Nonconforming
<b>CAPA Part</b>	<input checked="" type="checkbox"/> Conforming <input type="checkbox"/> Nonconforming

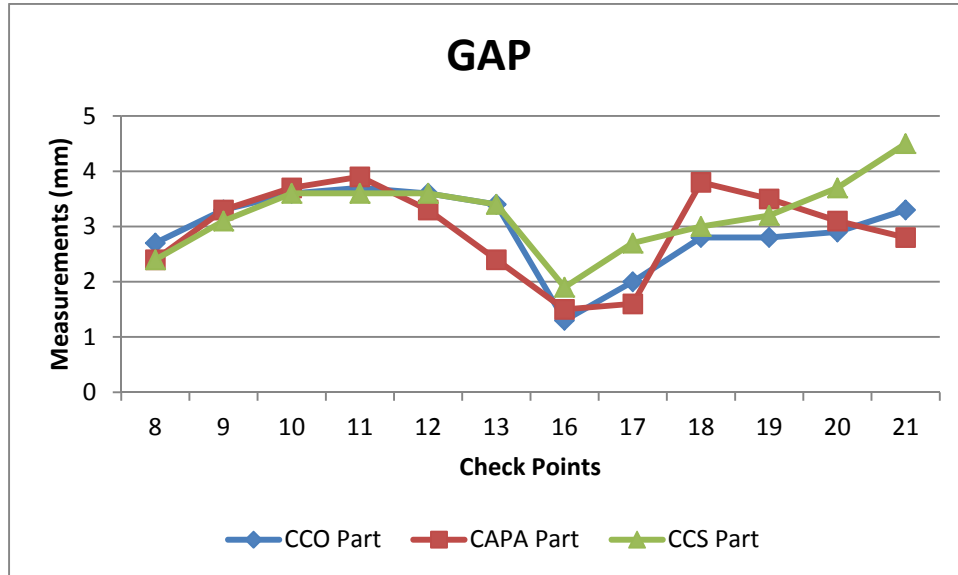
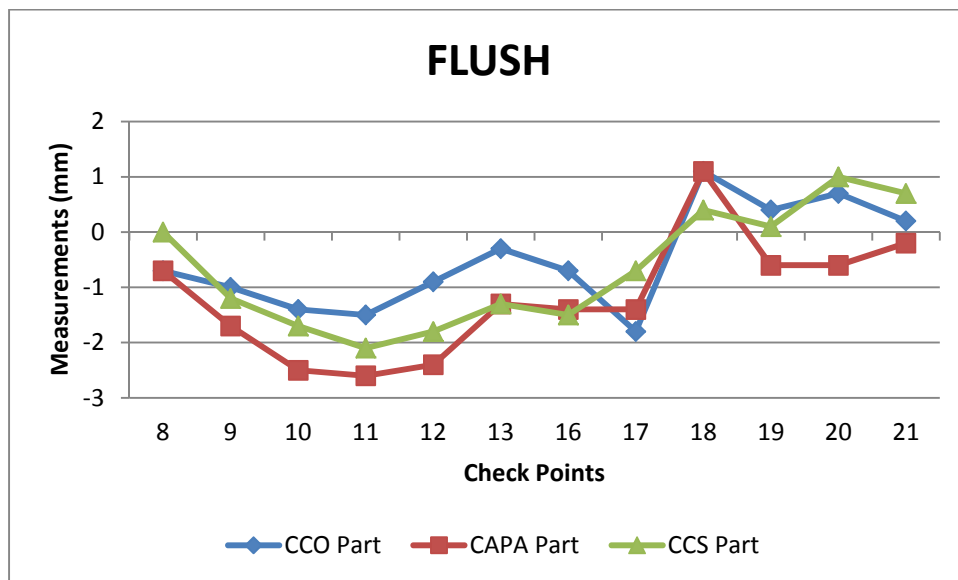
### Vehicle Test Fit Dimensional Data Plot

GAP			
	CCO Part	CAPA Part	CCS Part
1			
2			
3			
4			
5			
6			
7			
8	2.7	2.4	2.4
9	3.3	3.3	3.1
10	3.6	3.7	3.6
11	3.7	3.9	3.6
12	3.6	3.3	3.6
13	3.4	2.4	3.4
14			
15			
16	1.3	1.5	1.9
17	2.0	1.6	2.7
18	2.8	3.8	3.0
19	2.8	3.5	3.2
20	2.9	3.1	3.7
21	3.3	2.8	4.5
22			
23			
24			
25

FLUSH			
	CCO Part	CAPA Part	CCS Part
1			
2			
3			
4			
5			
6			
7			
8	-0.7	-0.7	0
9	-1.0	-1.7	-1.2
10	-1.4	-2.5	-1.7
11	-1.5	-2.6	-2.1
12	-0.9	-2.4	-1.8
13	-0.3	-1.3	-1.3
14			
15			
16	-0.7	-1.4	-1.5
17	-1.8	-1.4	-0.7
18	1.1	1.1	0.4
19	0.4	-0.6	0.1
20	0.7	-0.6	1.0
21	0.2	-0.2	0.7
22			
23			
24			
25

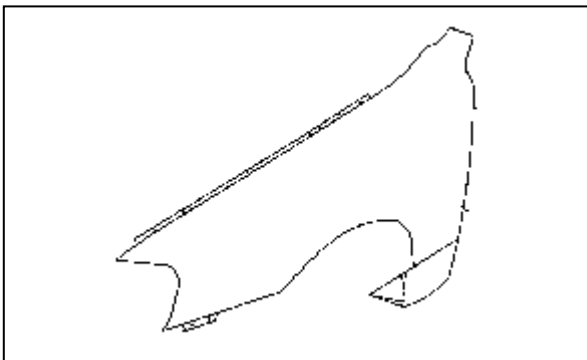
### Part Appearance Inspection Results

Defects Identified in Complaint:  
 Surface - wavy/warped/distorted  
 Around wheel well area has mfg defect same spot inner fender bolts to.

<b>CCS Part</b>	<input checked="" type="checkbox"/> Conforming <input type="checkbox"/> Nonconforming

<input type="checkbox"/> Conforming <input checked="" type="checkbox"/> Nonconforming

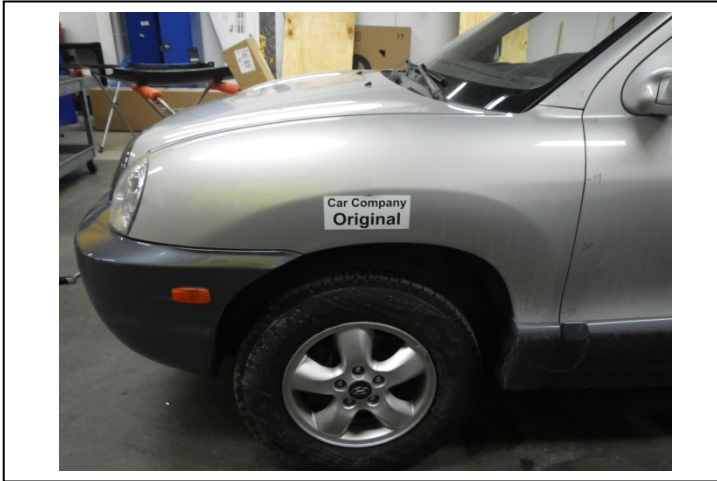
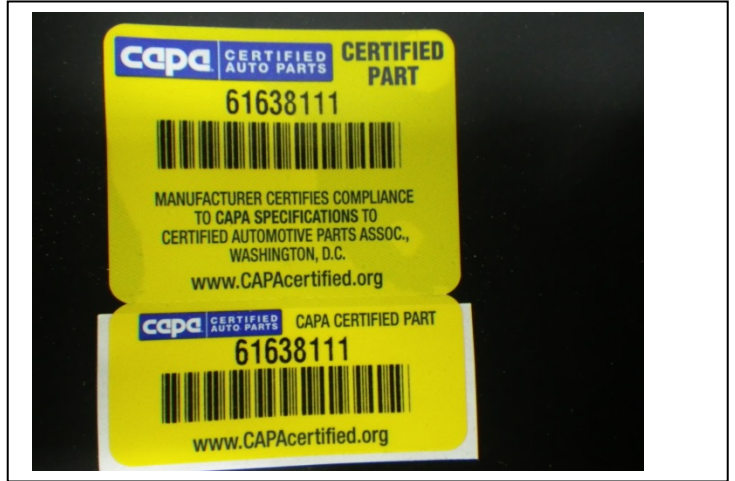
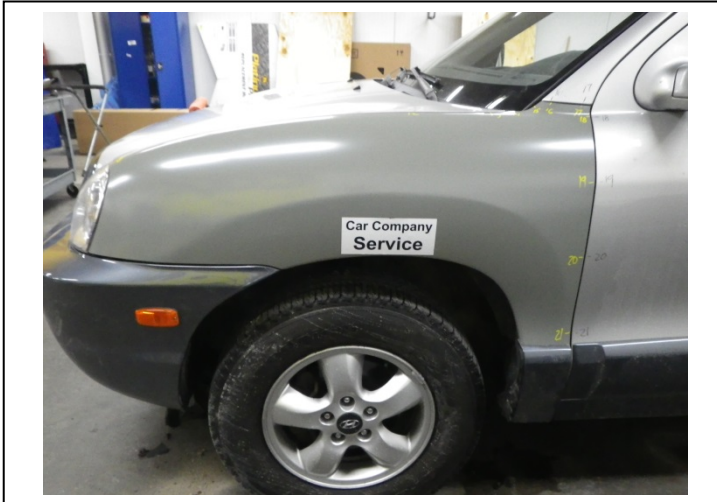
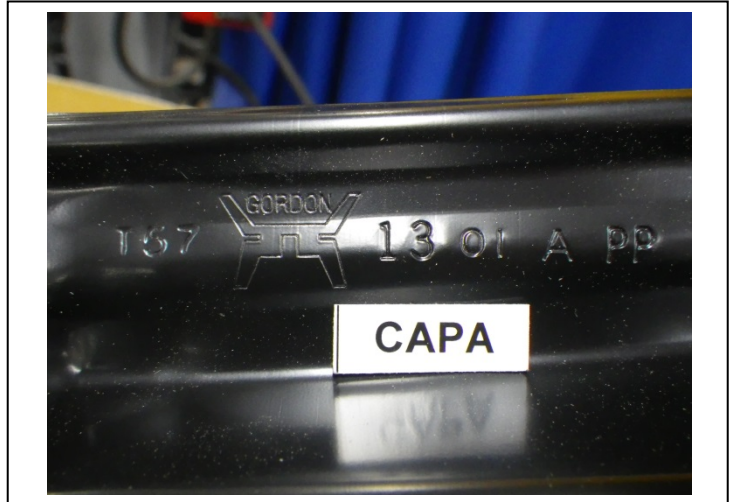
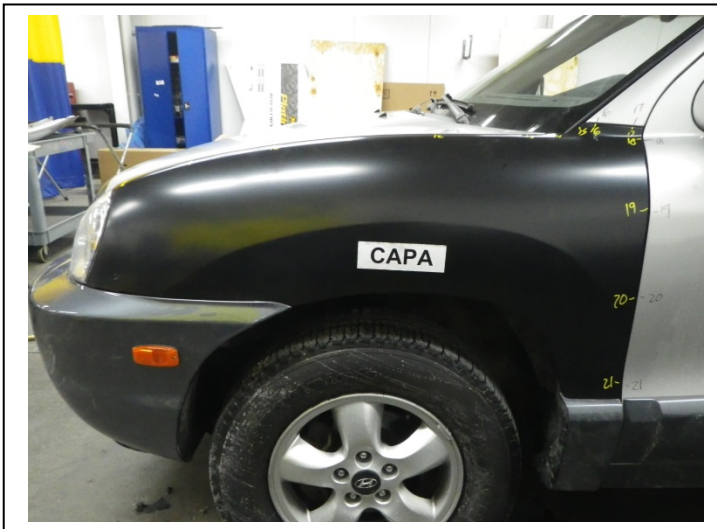
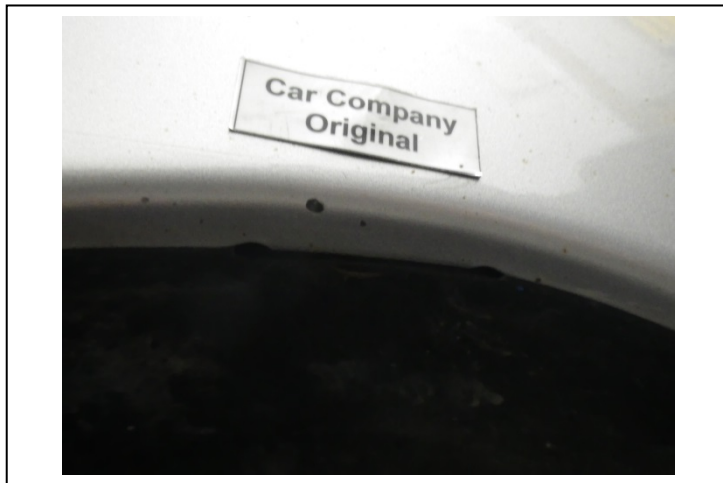
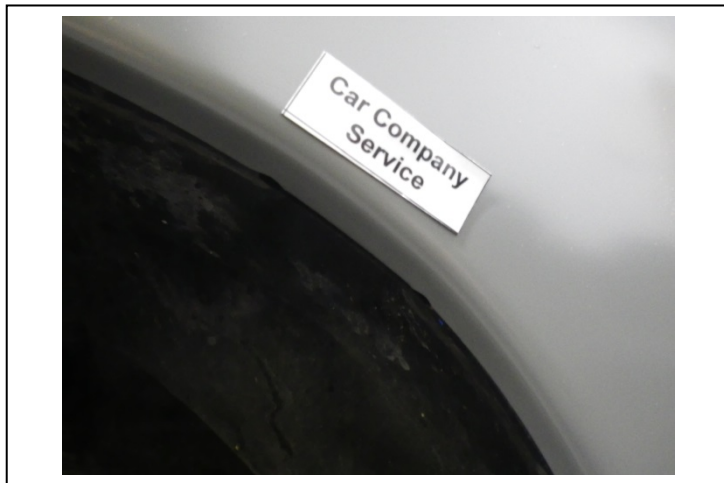
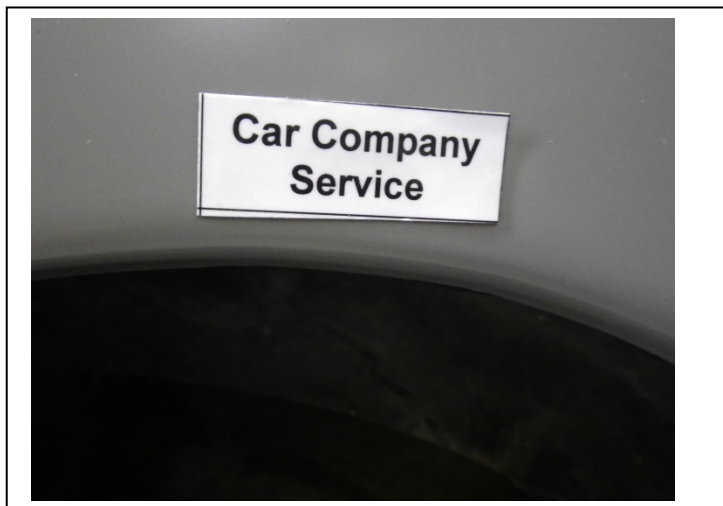
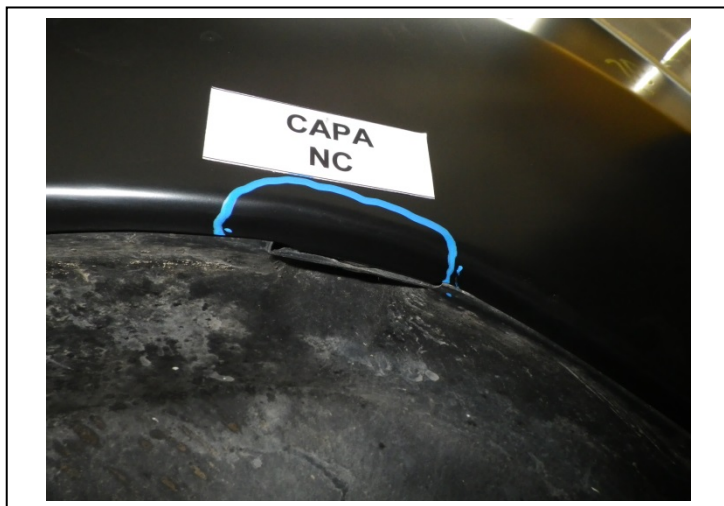
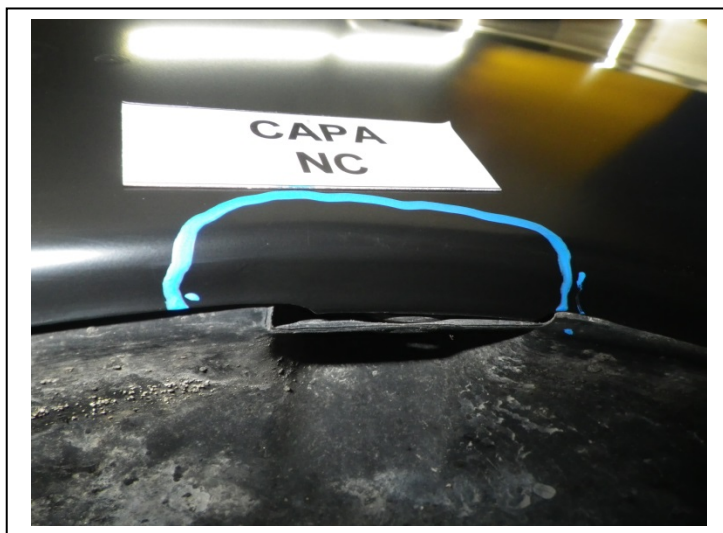
### VTF Photos

Complaint Defects Verified:	<input checked="" type="checkbox"/> All	<input type="checkbox"/> Some	<input type="checkbox"/> None	<input type="checkbox"/> Inconclusive
Additional Nonconformances Identified:	<input type="checkbox"/> Yes	<input checked="" type="checkbox"/> No

Further Action Needed:	<input checked="" type="checkbox"/> In-Factory Inspection		
	<input checked="" type="checkbox"/> CAR Issued: 13-1787		
Status of Lot Certification:	<input type="checkbox"/> Remain Certified	<input checked="" type="checkbox"/> Decertified	
Status of Part Certification:	<input checked="" type="checkbox"/> Remain Certified	<input type="checkbox"/> Decertified
