## Product Technical Info

### TIMING BEL KIT - TBK5085.11

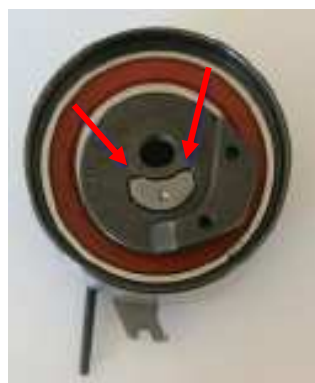
Fig.1

AVVERTENZE SUL CORRETTO MONTAGGIO	WARNING INSTRUCTIONS FOR A CORRECT ASSEMBLY
<p>Consultare le corrette procedure di installazione del Costruttore del veicolo al fine di evitare la rottura della piastrina posta sopra al tenditore (Fig.1).</p> <p>Tale piastrina è provvista di due piccoli fori che servono alla messa in fase del tenditore stesso.</p> <p>L'ancoraggio della piastrina di registrazione al perno centrale è realizzato per interferenza su una sporgenza del perno stesso. Il perno centrale è costruito, così come previsto dal Costruttore del veicolo, in <b>materiale sinterizzato</b>. Ne deriva che a fronte di una elevata capacità meccanica, si ha una altrettanto elevata fragilità in caso di urti, sforzi e/o movimenti non allineati all'asse del tenditore stesso.</p> <p><b>La piastrina deve essere utilizzata solo ed esclusivamente per la messa in fase del tenditore.</b> Questa operazione deve essere effettuata con attrezzatura idonea ed appropriata, come raccomandato dal Costruttore del veicolo. In Fig.2 è riportata l'immagine di esempio di un tenditore con rottura della piastrina a causa di una errata operazione in fase di montaggio.</p>	<p>Refer to the correct assembly procedures given by the vehicle manufacturer to prevent the breakage of the plate above the tensioner (Fig. 1).</p> <p>This plate has two small holes used to time the tensioner.</p> <p>The securing of the adjustment plate to the central pin is made by interference on a projection of the same pin. As instructed by the vehicle manufacturer, the central pin is made of <b>sinterised material</b>. Therefore, though it is mechanically highly resistant, it is also extremely brittle in the case of shocks, strains and/or movements misaligned to the tensioner axis.</p> <p><b>The plate must be used only and exclusively for tensioner timing.</b> This procedure must be performed using suitable and appropriate tooling, as recommended by the same manufacturer. Fig. 2 shows an example of a tensioner where the plate is broken due to a wrong assembly procedure.</p>
