V40-63-0007

Please note the following instructions before replacing the EGR valve!

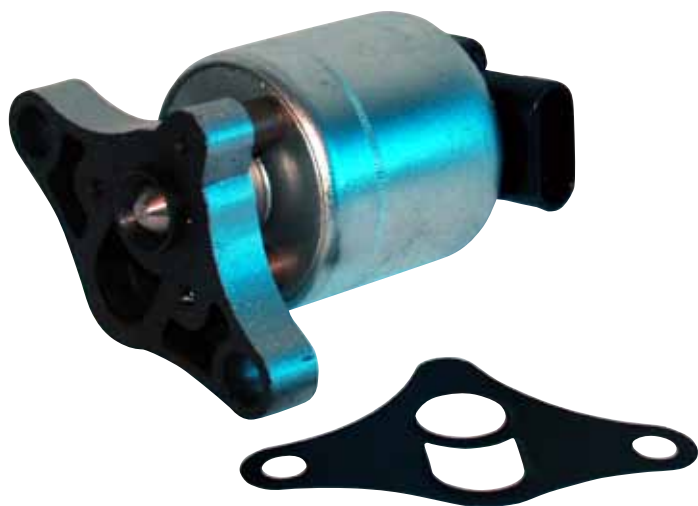
Malfunction of the EGR valve are often caused by carbon particulate between piston rod and guide.

Before replacing the EGR valve, please make sure that the EGR valve and the other engine management components are checked according to the manufacturer's manual and inspection instructions.

Prior to installation of a new EGR valve, the cause(s) of failure should be diagnosed and corrected.

The software of the engine management has to be updated, if necessary.

It is essential to replace also the gasket, which is supplied with the EGR valve!
